MSC APOLLO 13 INVESTIGATION TEAM

SPACECRAFT
INCIDENT INVESTIGATION

VOLUME II

MANUFACTURING AND TEST HISTORY
OF OXYGEN TANK

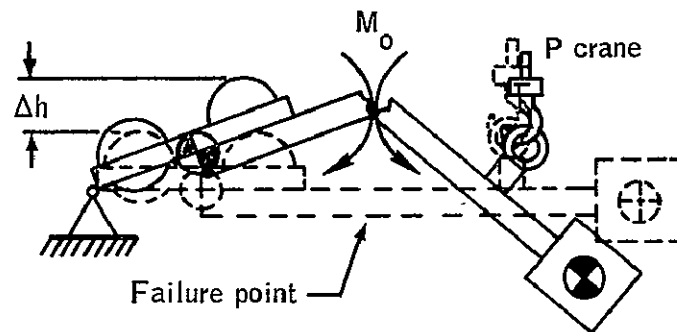
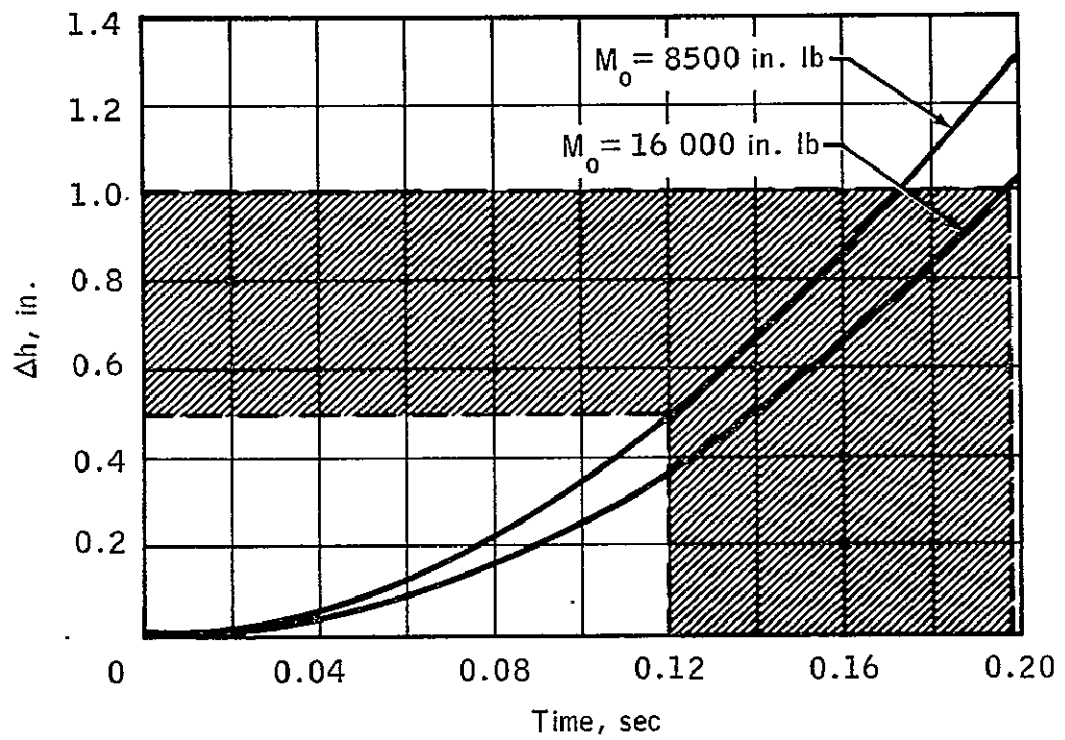
Figure 2-4.- Postfailure dynamics .

Case I.— The rate at which the weld fails, as shown in figure 2-4, determines the displacement and velocity of the top of the tank. Calculated times greater than 0.1 second were required to produce an impact of the tank and the fuel cell shelf. This slow failure of the weld was considered improbable.

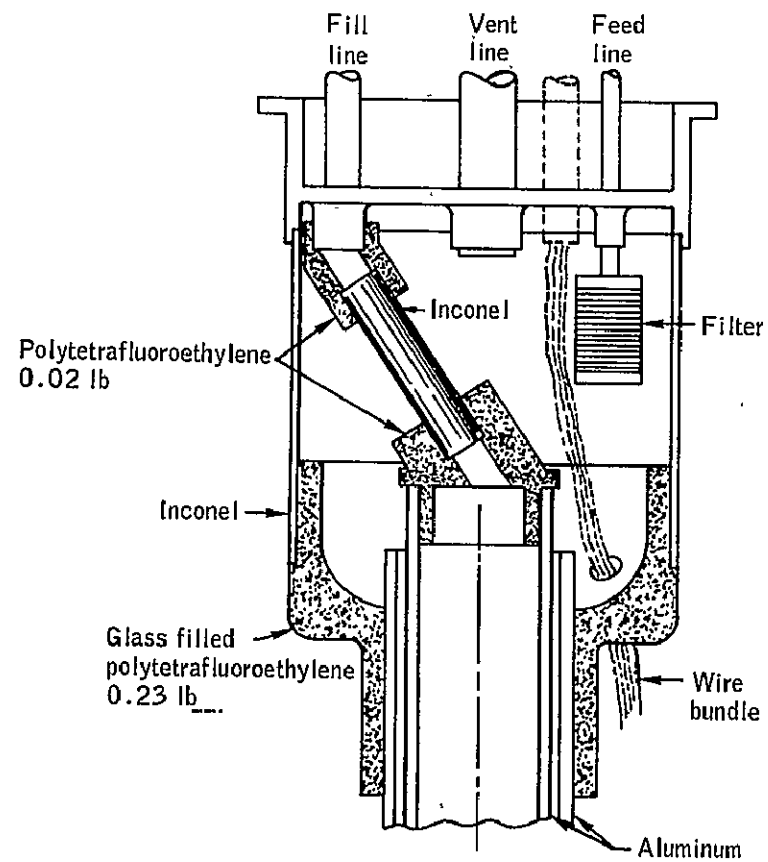
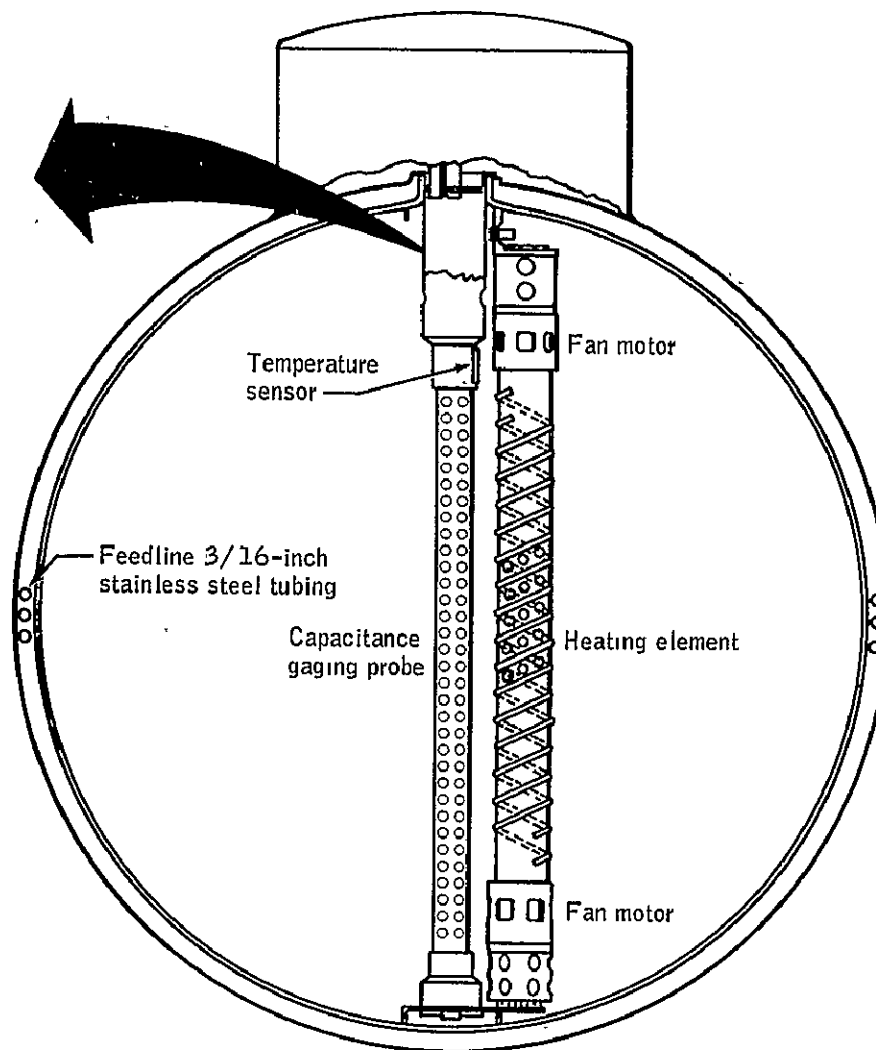
Figure 3-1.- Arrangement of components within oxygen tank.

In general, liquid oxygen tank 2 could not be off loaded after its initial filling during countdown demonstration test. The problem was assumed to be due to missing or broken pieces, or to a tolerance buildup under cryogenic conditions, within the dog leg portion of the tank fill path (reference Figure 3-1).

The effect of this damage on the tank in-flight performance was judged to be inconsequential since all other aspects of tank performance were nominal. In addition, the available energy was determined to be minimal both from small Teflon particle fan impeller impacting and from probe plate-to-plate shorting by the inconel tube.

After numerous attempts with gaseous oxygen purges and higher expulsion pressures, the fluid was boiled off through the use of tank heaters and fans, assisted with pressure cycling. As established from the recorded data, the heater thermal switches did not open. There was no evidence of concern or consideration given to the possibility of internal wire damage resulting from overheating. There are no apparent specifications that prohibit this activity.

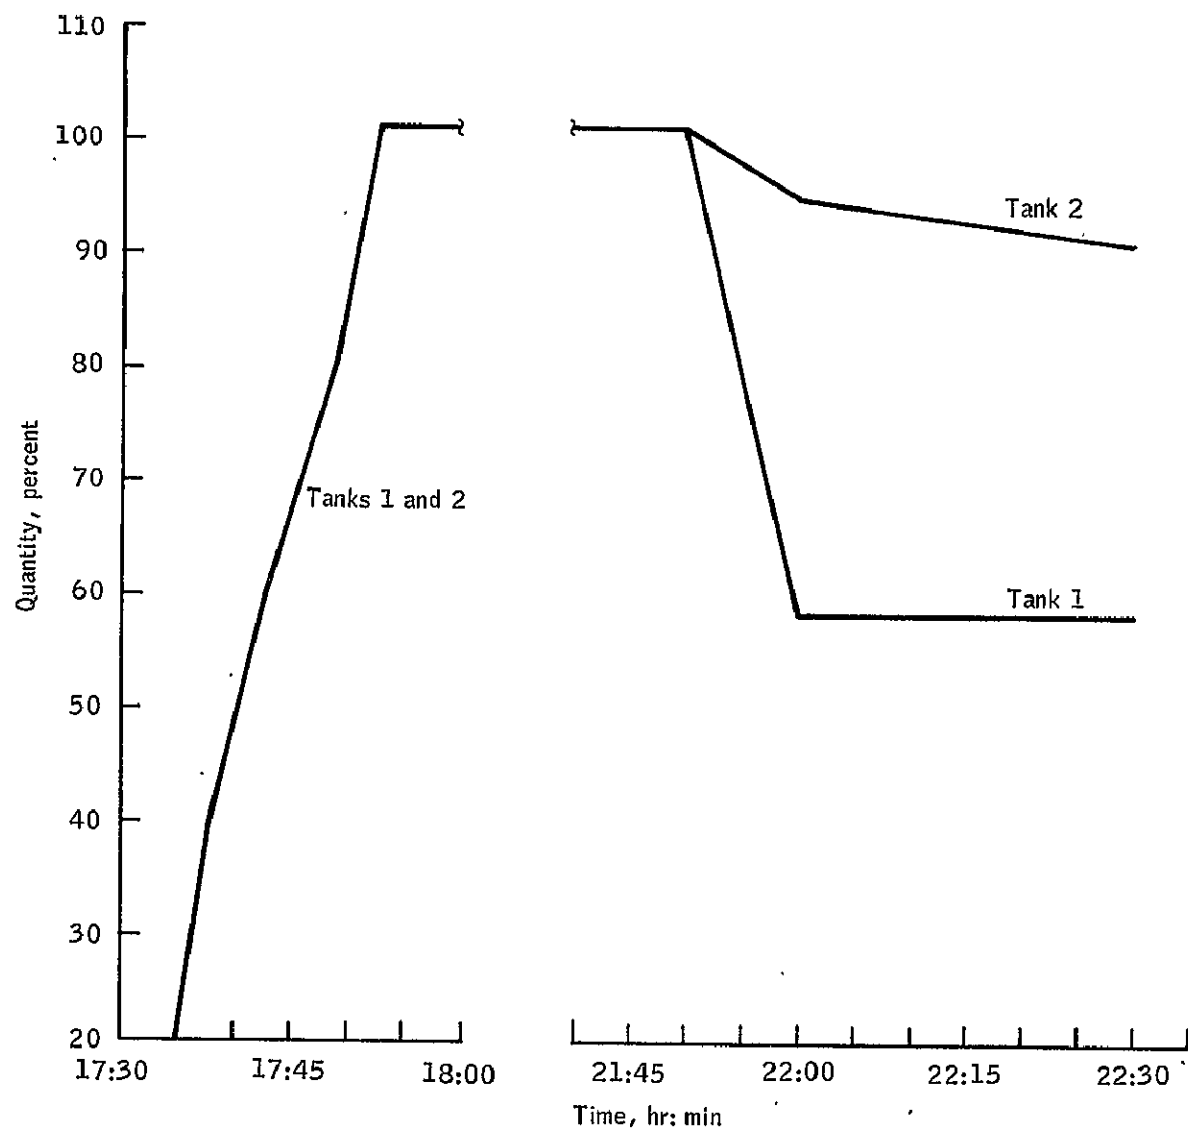
Figure 3-7.- Oxygen tank 2 quantity adjust (CDDT).

In the ten-minute period required by tank no. 1, the quantity in tank no. 2 had decreased to only 96% (fig. 3-7). Several cycles were attempted to insure no stuck valves.

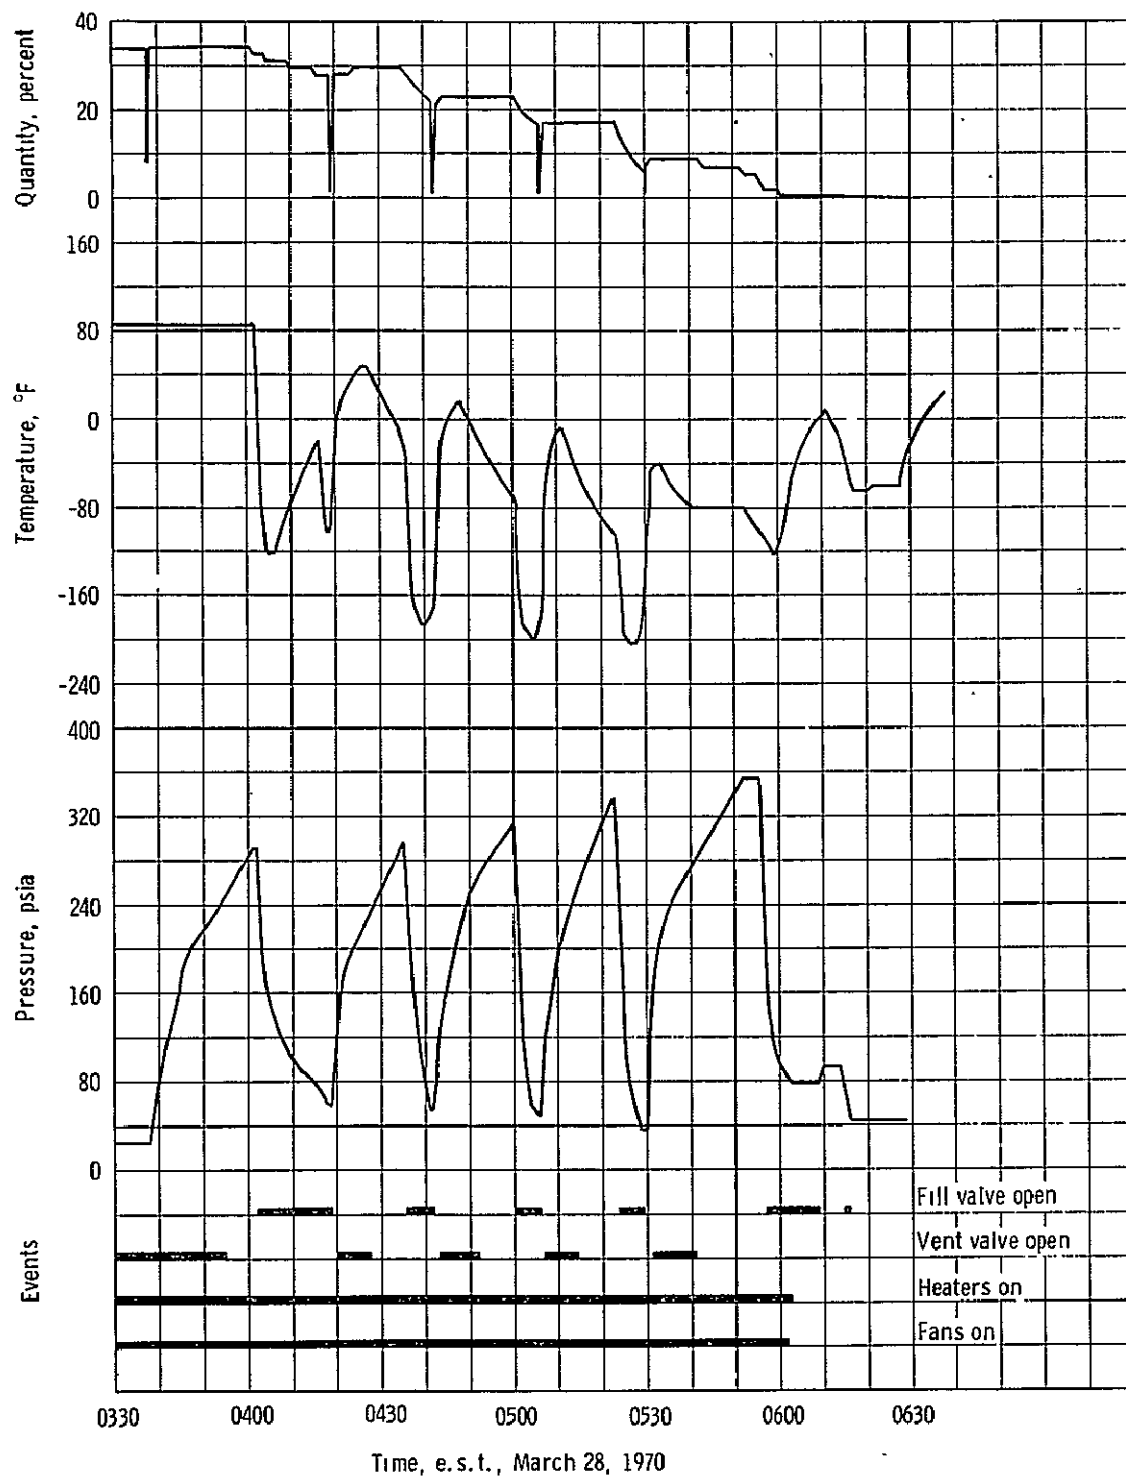
Figure 3-11.- Characteristics of oxygen tank 2 detanking using fans, heaters, and GSE pressure (CDDT).

7% (from 35% to 28%). The results were considered excellent and the tank was emptied with four additional cycles. Tank behavior and valve cycles can be found in figure 3-11.

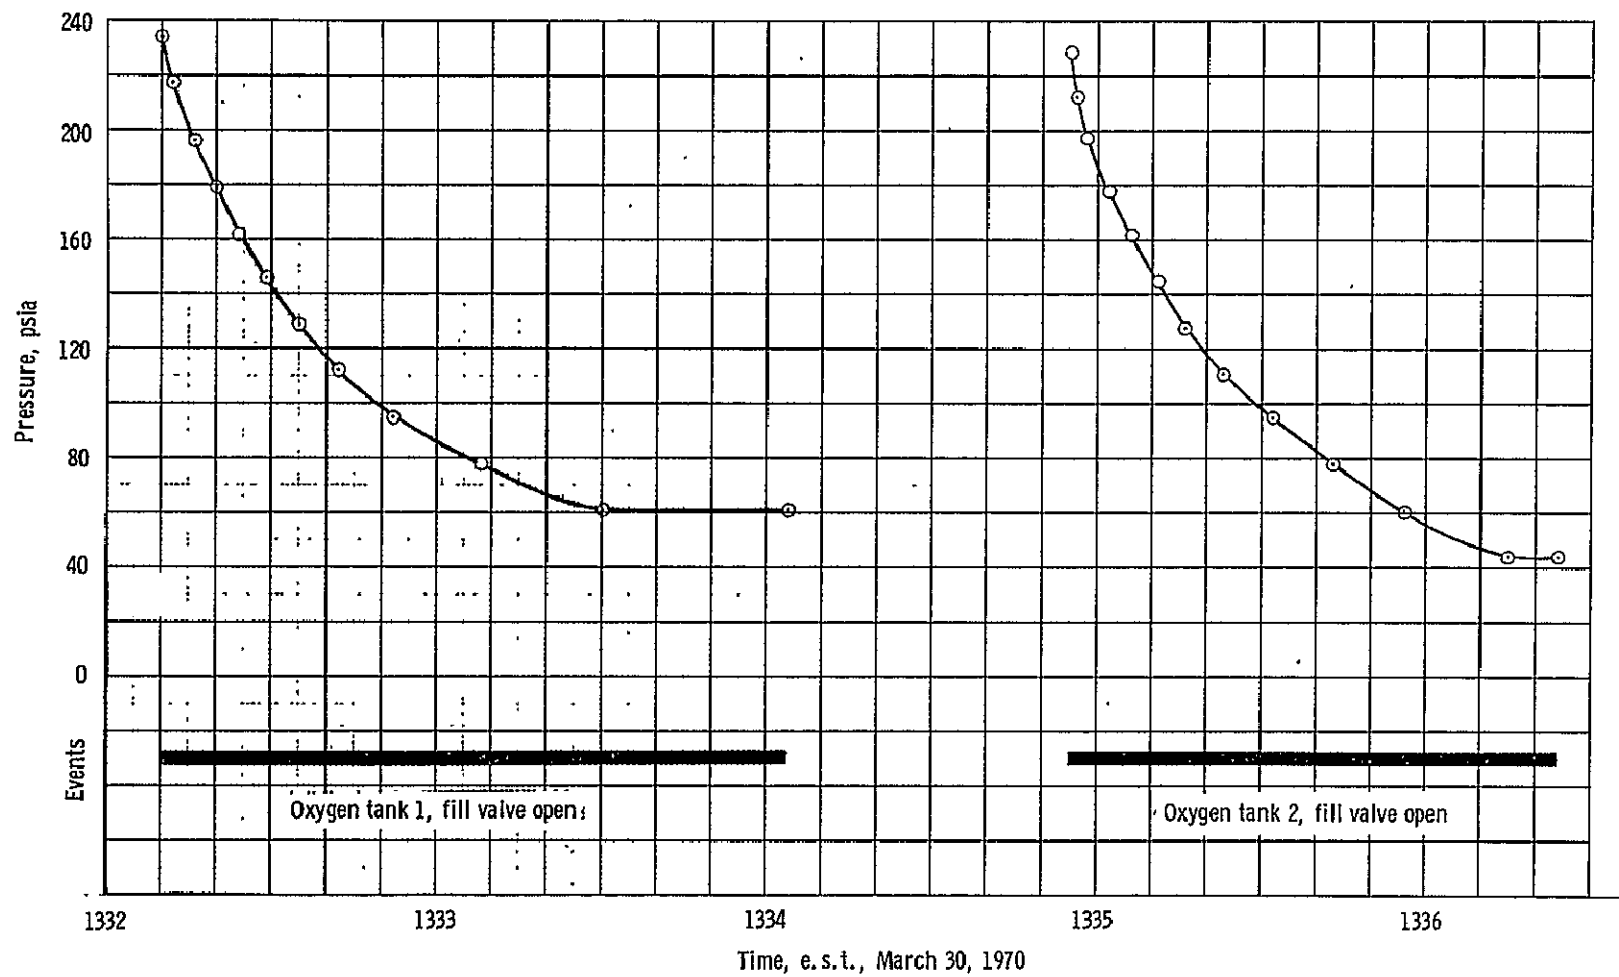
Figure 3-12. - Gaseous oxygen blowdown test, spacecraft 109.

At 13:30 both tanks were pressurized to approximately 250 psia and vented through the fill lines (tank no. 1 and then tank no. 2). With the exception of an apparent leak from tank no. 2 vent POD that caused a slight increase in tank no. 1 final pressure (this POD was capped for launch to stop the leak) both curves were essentially identical (fig. 3-12). Tank no. 1 dropped 135 psi, in 40 seconds while tank no. 2 dropped 140 psi, indicating no permanent line restrictions.

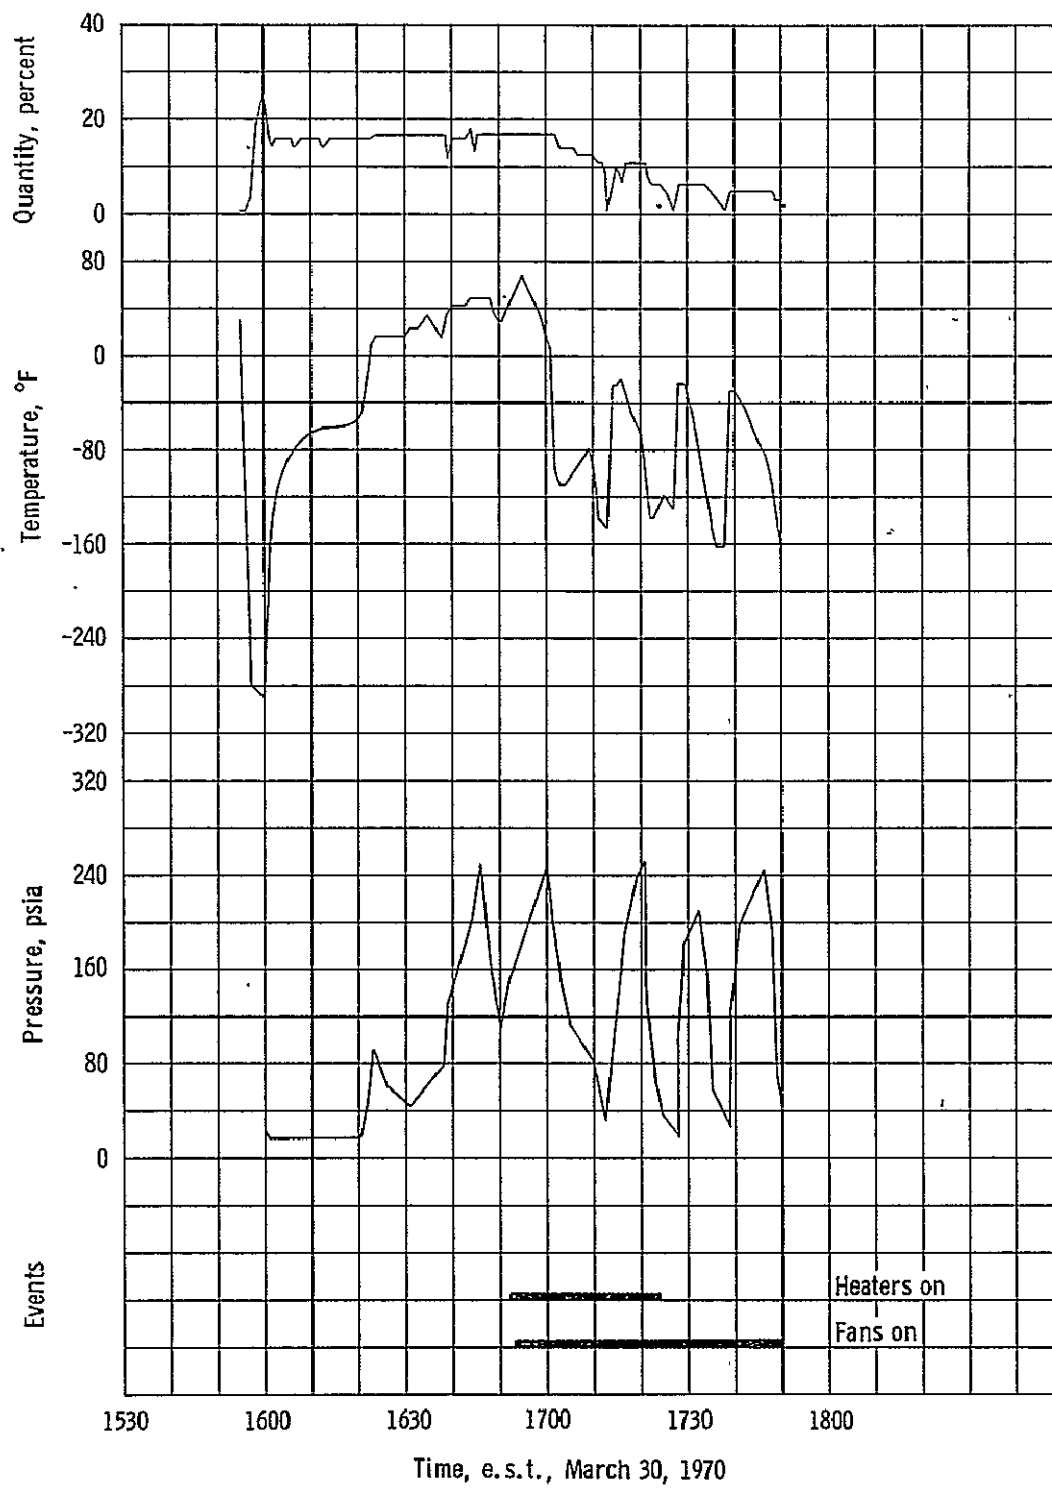
At 15:50, O₂ tank no. 2 was successfully filled to 17% with liquid oxygen. Detanking was accomplished over the next two hours (fig. 3-13) with five pressure cycles. Heaters remained on for approximately 32 minutes.

Figure 3-13. - Characteristics of oxygen tank 2 detanking using fans, heaters, and GSE pressure (post CDDT).

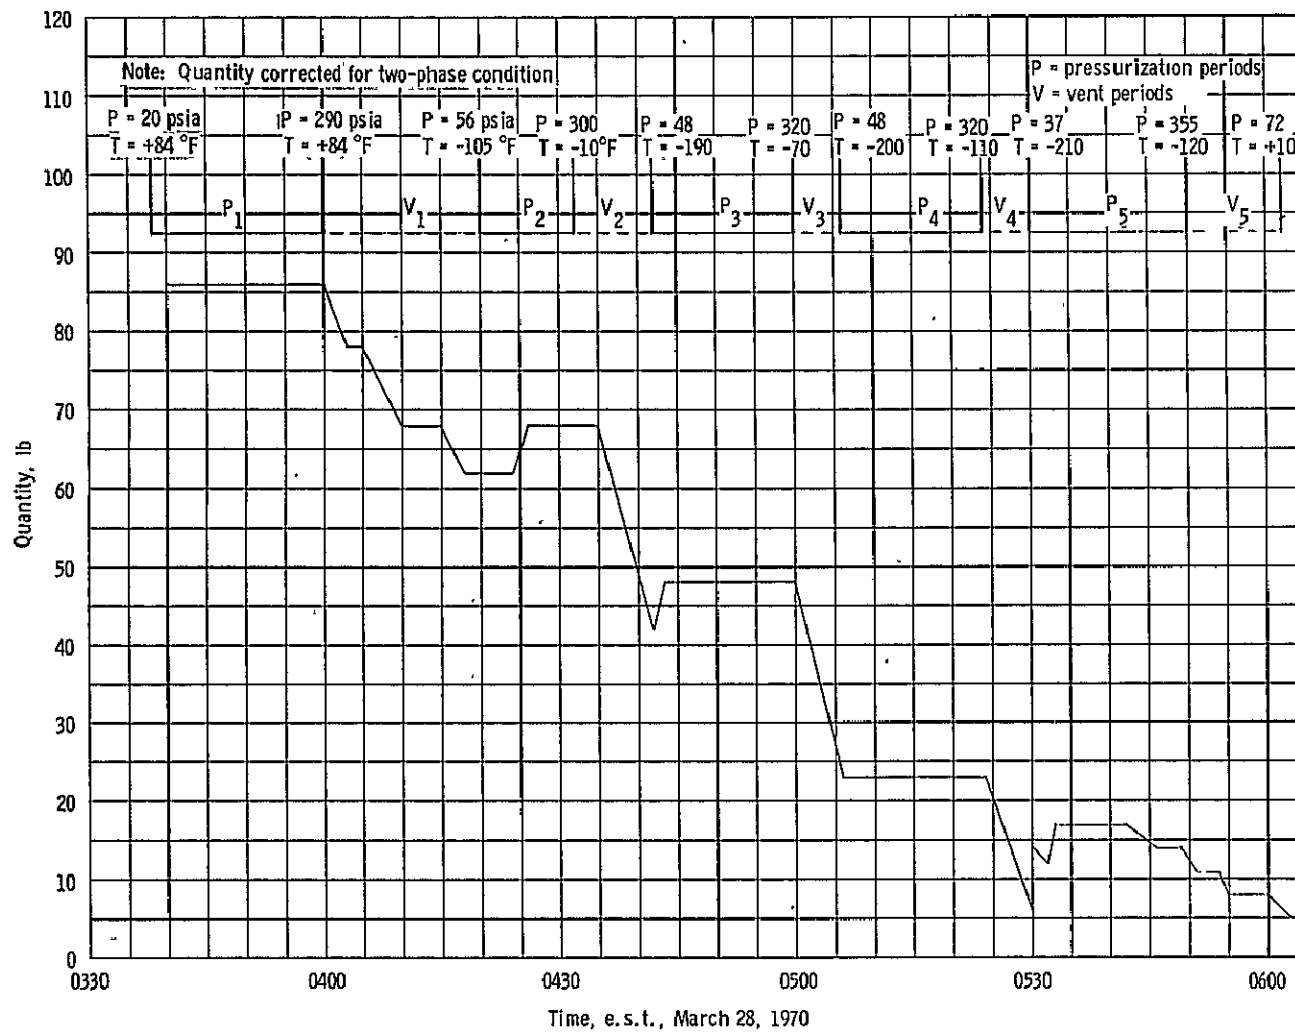
From figure 3-15 the maximum detanking rate occurred during the third venting. From the quantity gage readout over the six minute period, the flow rate was 0.07 lb/sec. Since the fluid quantity flowing

Figure 3-15. - Oxygen quantity during detanking.

The highest possible velocity, and consequently the worst damage potential, will occur if there is no hole. Eliminating the hole, V_p of the media calculates to 30.2 lb/ft²/sec, and using the density of liquid oxygen at 180 psia, the velocity of fluid in the standpipe must be 0.5 ft/sec. This requires a driving pressure of only 0.0016 psi, and while the actual pressure cannot be established, it is known to be in excess of 100 psi. From this it can be seen that the average density must be appreciably lower, and that the exit media could not have been liquid over the 6 minutes examined.

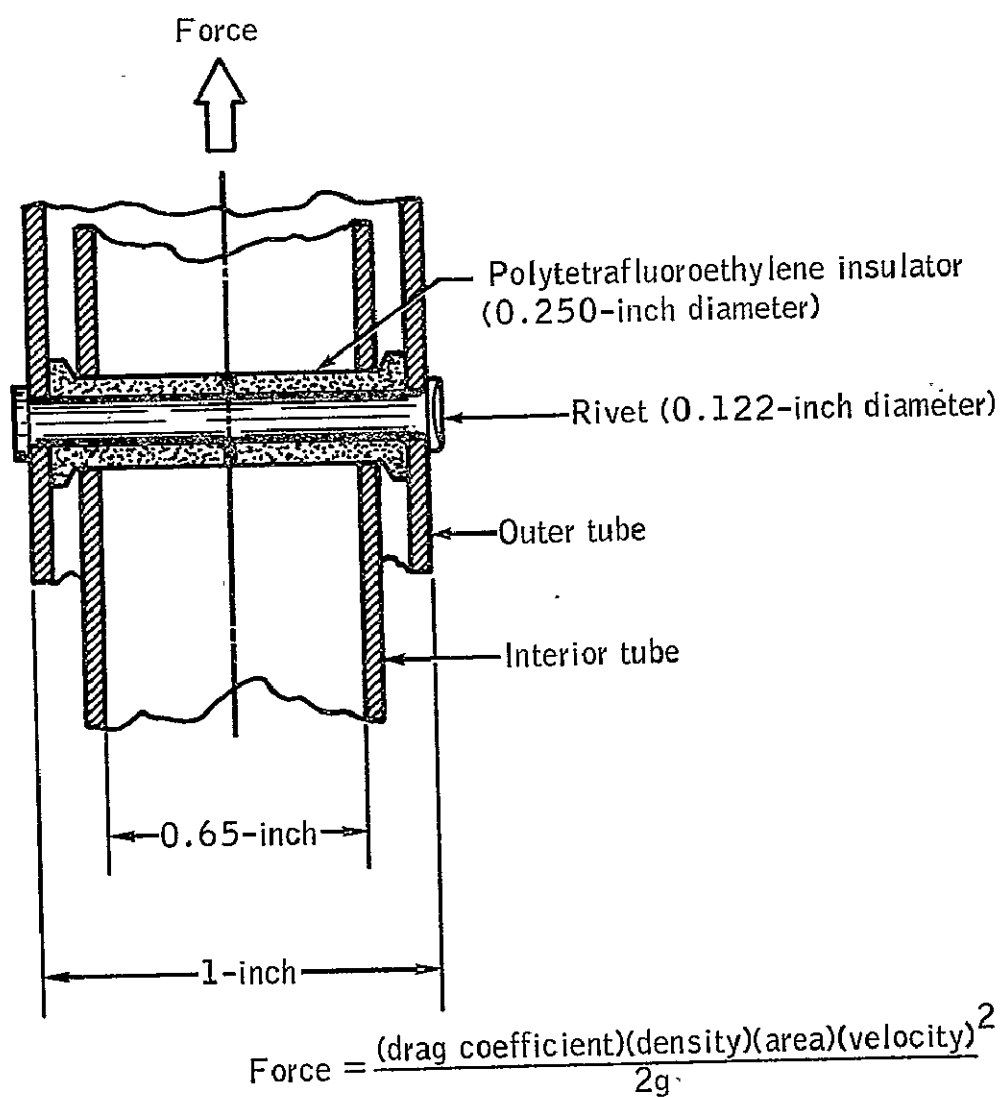
Assuming liquid flow, the maximum pressure differential used, and assuming no significant velocity in the tank bulk fluid, then, for the configuration shown in figure 3-16, the velocity will be 238 ft/sec. Computing a Reynolds number to establish a drag coefficient of 1.2, the force on the rivet can be calculated to be 63.0 pounds.

The actual force seen by the rivet was, of course, significantly less since there was an appreciable leak between the tank and the fill path at the upper end. The assumed 320 psi delta could not have existed. If a pressure of even 100 psi could have been sustained, then the force would drop to as little as 11 pounds. The actual failure point of the rivet was determined to be 105 pounds by static load (reference MSC test No. TPS-13-T-60).

Figure 3-16.- Density probe cross section showing fluid force on the rivet.

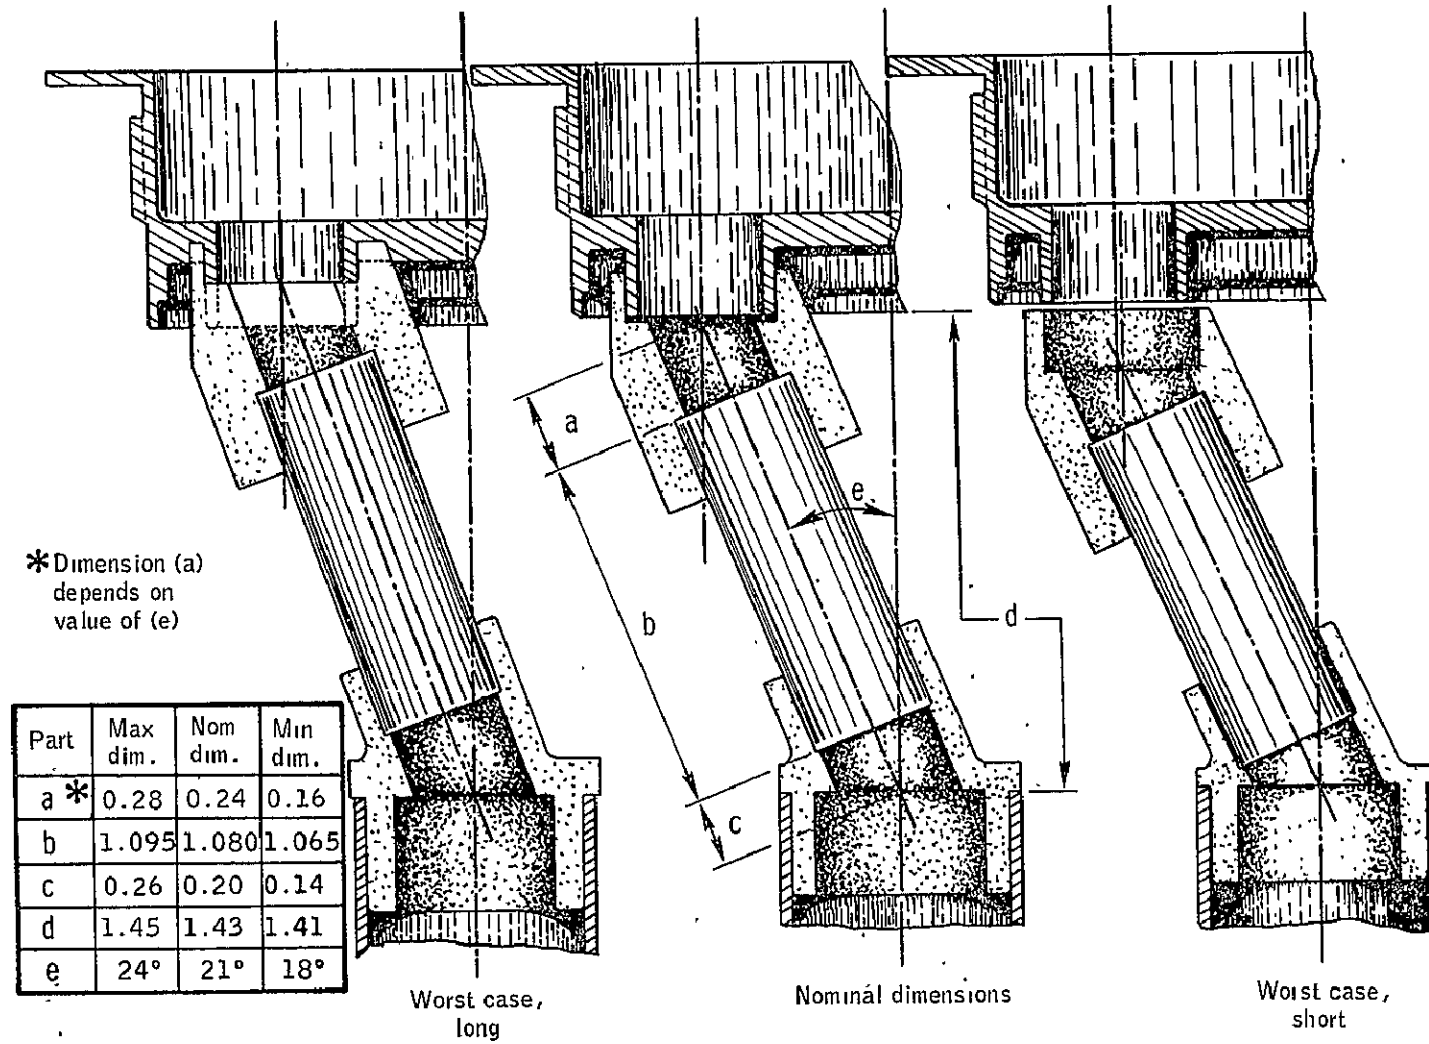
Torque on Probe Dog-Leg. - This analysis shows that the normal fluid-produced torque on the probe dog-leg assembly would be sufficient to dislodge it under the correct manufacturing tolerance conditions (fig. 3-17).

Assuming the maximum pressure differential that would occur during normal detanking (as the fluid interface rises to contact the first bend) (fig. 3-18) and with no velocity in the tank bulk fluid, then the stand pipe velocity is calculated to be 139 ft/sec. Equating the upward force to the sum of the momentum force and the pressure force, F_u is calculated to be 58.0 pounds, with the moment 32.4 in-lbs. Utilizing measured flow rates during a normal detanking, the moment can be reduced to 5.3 in-lbs. This is still adequate to produce motion. Detanking tests at Beech Aircraft have shown that fluid will be expelled in the worst case short (fig. 3-17) only if the assembly is exactly aligned.

Figure 3-17.- Manufacturing tolerance study.

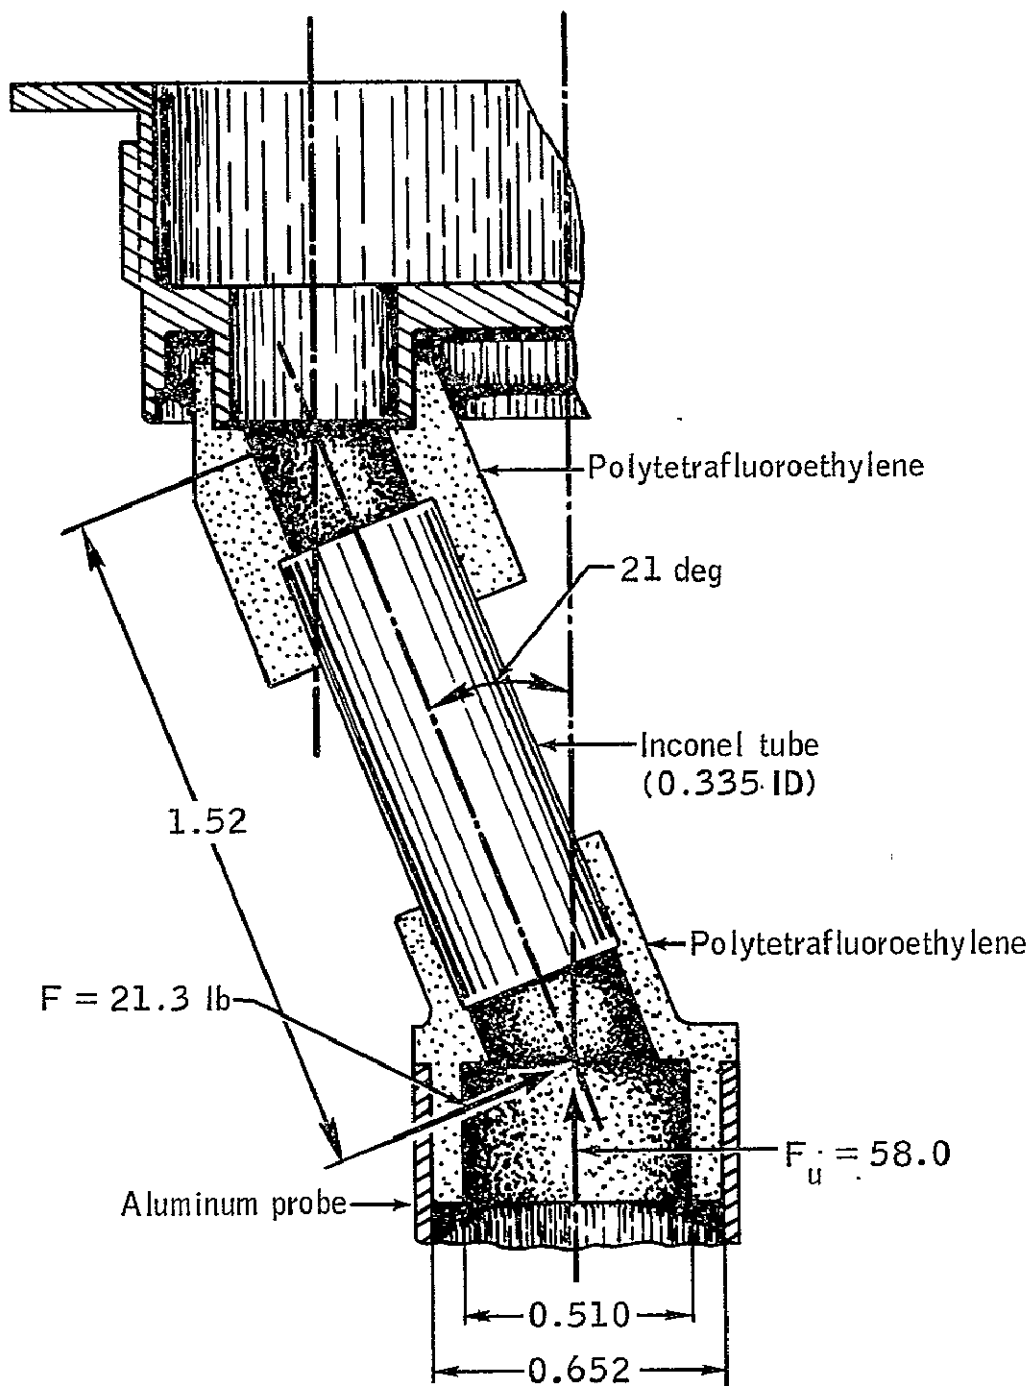
Figure 3-18.- Standpipe assembly at the top of the tank.
